**M&M Home Inspections**  
**757-374-7271**  
**[www.mmhomeinspection.com](http://www.mmhomeinspection.com)**

Client Information: Record Number 4908 Powahatan  
**Jones, Mark** Ave

Inspected 2/21/14 12:00 PM

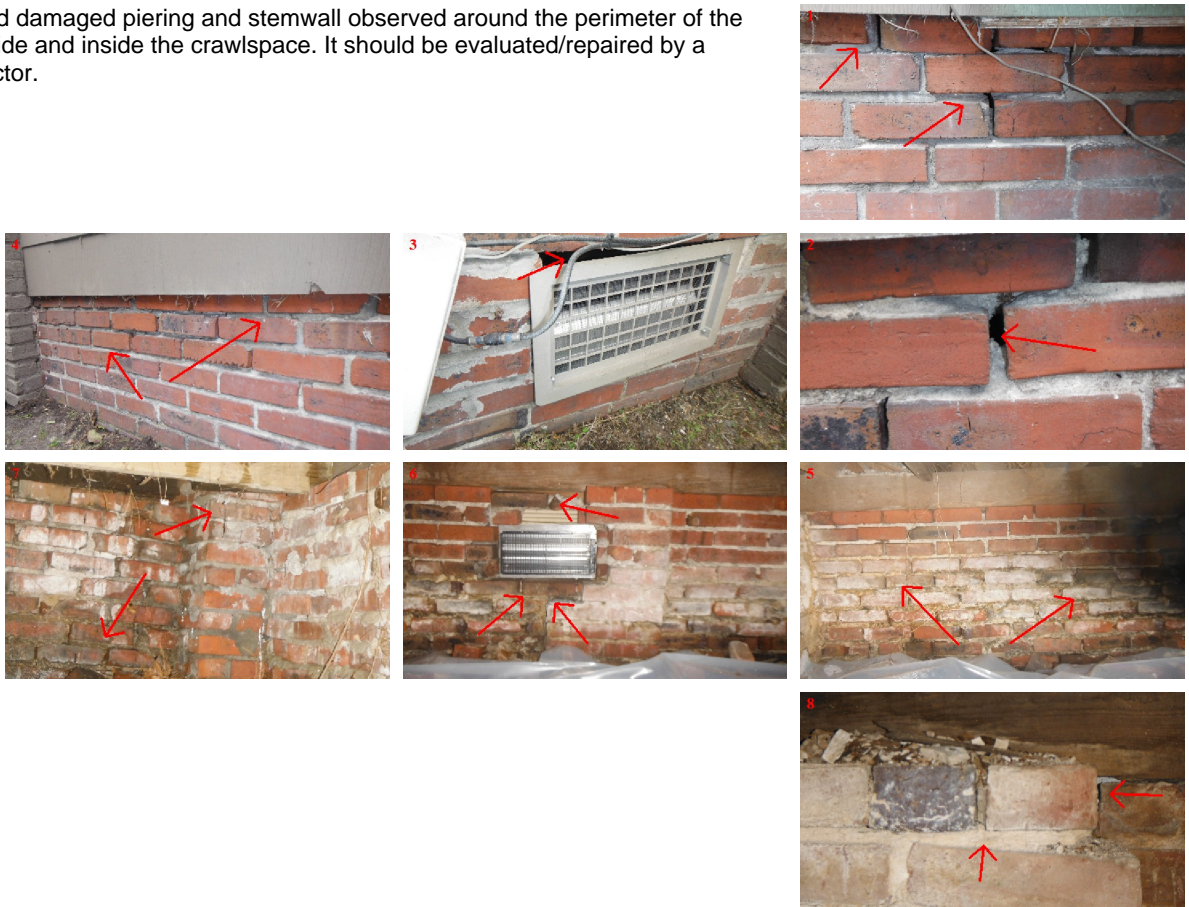
Deteriorated and damaged piers and stemwall observed around the perimeter of the home both outside and inside the crawlspace. It should be evaluated/repared by a licensed contractor.

Deteriorated and damaged piering and stemwall observed around the perimeter of the home both outside and inside the crawlspace. It should be evaluated/repaired by a licensed contractor.

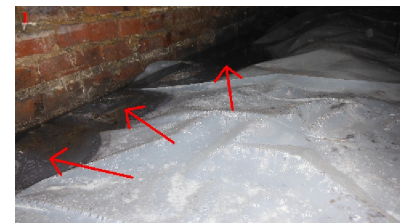
Standing water was observed in the crawl space area at the back of the main home. Chronic standing water will contribute to the growth of mold, mildew, fungus, and to the premature deterioration of wood framing components. Have further evaluated and/or repaired as necessary by a qualified contractor.

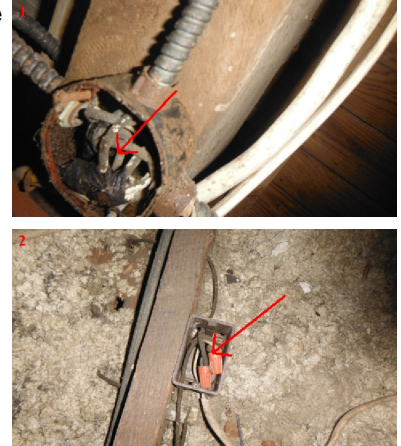
Junction box/es and/or service disconnect box/es is/are missing cover/s. Covers should be installed to help prevent fires and shock hazards. Location/s - crawlspace and attic

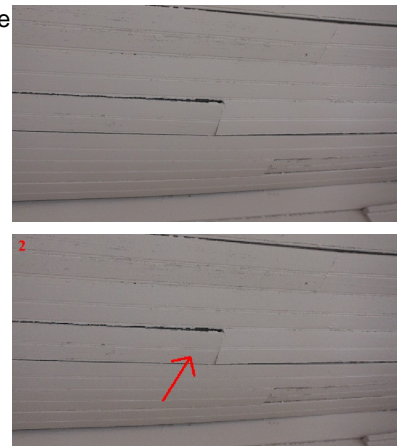
Ceiling structure in the upstairs front Florida Room is loose and not properly attached to the joist assemblies. The potential for it to fall is a safety hazard.

Low head clearance at the kitchen bath entry.
